Failure Analysis of a Four Cylinder Diesel Engine Crankshaft Made From Nodular Cast Iron

Abstract

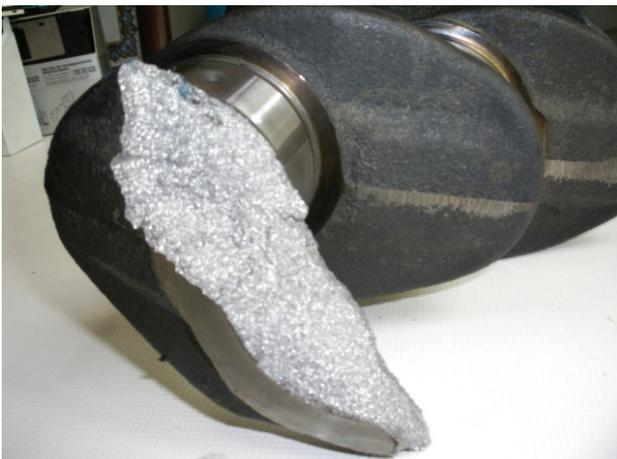
A broken crankshaft is shown in Fig. 1. The Fractured surface shows a brittle appearance and no Beachmark was observed on the failed region. Fig. 2 shows the microstructure of the material. spherical nodules of graphite surrounded by ferrite in a perlitic matrix is observed.

Fig 1. The fractured surface of the crankshaft

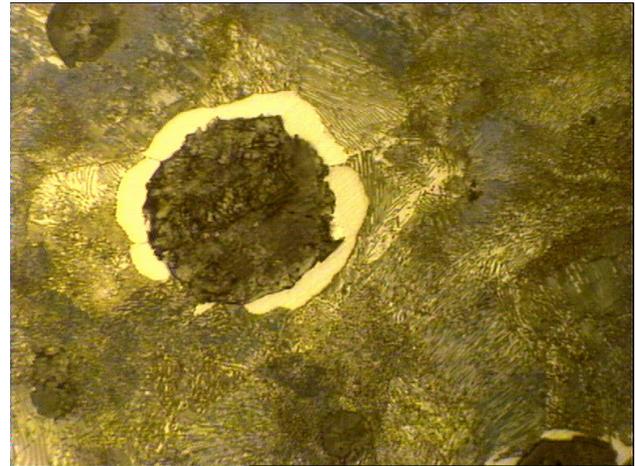
Fig 2. Optical micrograph of the material

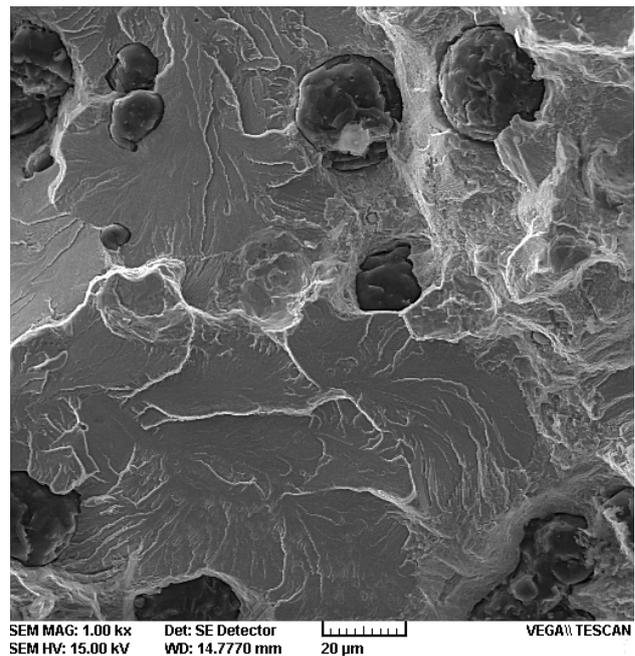
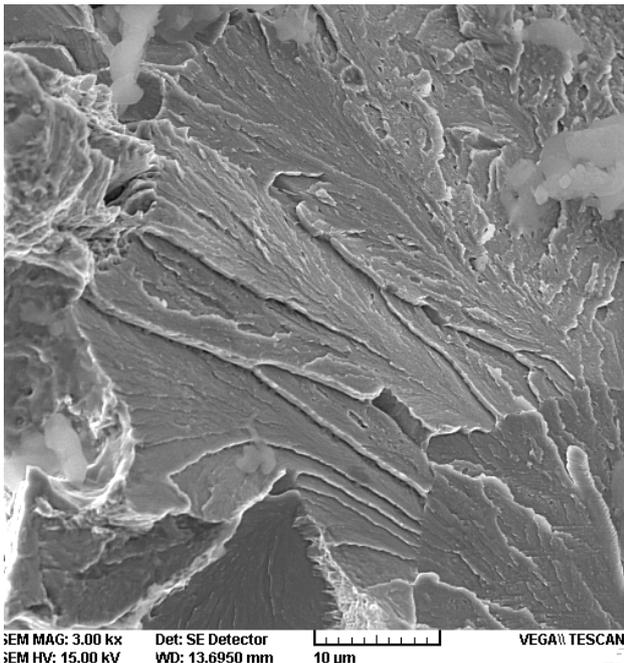
Figs 3 and 4 show SEM images of the fractured surface. The figures show cleavage fracture and put in evidence that the failure was brittle fracture. These two pictures are representative of the entire fracture surface. We could not observe any sign of fatigue failure. Therefore, fatigue is eliminated from the list of possible causes of the failure.

Fig 3. SEM image of the fractured surface

Fig 4. SEM image of the fractured surface

SEM images of the fractured surface also showed cleavage fracture and put in evidence that the failure was brittle fracture. No sign of fatigue failure was observed. The fracture may be caused by an overload. The above explained analysis showed that an overload could not be probable. Therefore, the problem lays in design procedure. The fracture which occurred from the fillet, suggests re-evaluation of the design. The fillet rolling may play an important role in this matter. Optimization of the fillet rolling process by changing process parameters has been recommended to

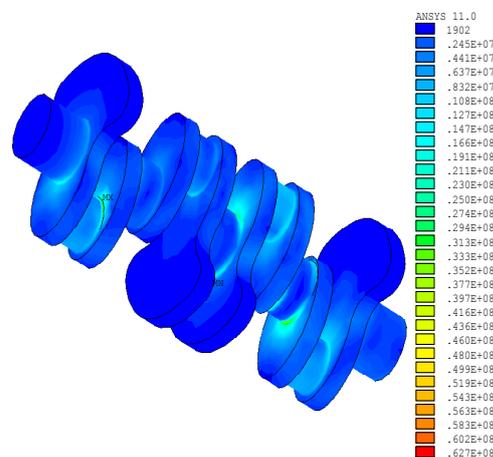
Four cases, i.e. combustion in each cylinder, were examined by alteration of the boundary condition in the finite element model. Results revealed that the most dangerous case has occurred in the first crankpin when the third cylinder was combusted. The equivalent von Mises stress distribution of the whole crankshaft during combustion of third cylinder is shown in Fig. 7. The maximum equivalent stress is 62.7 MPa which is about 15% of the yield stress of the material.

Fig 7. Equivalent von Mises stress distribution

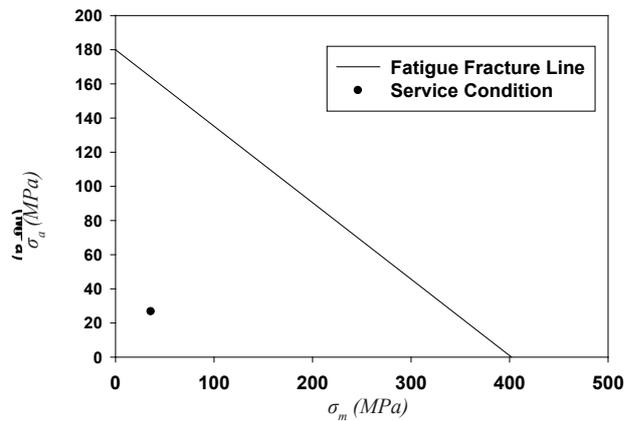
Knowing the fatigue limit and the yield stress of the material one can easily draw the Soderburg diagram. In the Soderburg diagram, the abscissa represents the amount of mean stress and the ordinate represents the amount of alternating stress. The region which is enclosed by abscissa, ordinate and the straight line between yield stress and fatigue limit is the safe region. In another words, if the point of service operation falls into this region, fatigue fracture will not occur. Fig. 8 shows the Soderburg diagram of the studied crankshaft along with the service operation point. This point stands for mean and alternating stresses of the first crankpin fillet that had been recognized as the most vulnerable point to fracture according to finite element results. Since the point was located in the safe region, it can be concluded that fatigue fracture has not occurred in the crankshaft. Calculations showed that the safety factor against the fatigue fracture was 4.77.

Fig 8. Soderburg diagram of the studied crankshaft

Soderburg diagram of the studied crankshaft showed that the service operation point, which stands for mean and alternating stresses of the critical region (first crankpin fillet) was located in the safe region. Therefore, it can be concluded that fatigue fracture has not occurred in the crankshaft.
