Failure analysis of an intake valve in a gasoline engine

M. Azadi^{1*}, M. Roozban², A. Mafi³

¹Fatigue and Wear Workgroup, Irankhodro Powertrain Company (IPCO), Tehran, Iran, m_azadi@ip-co.com

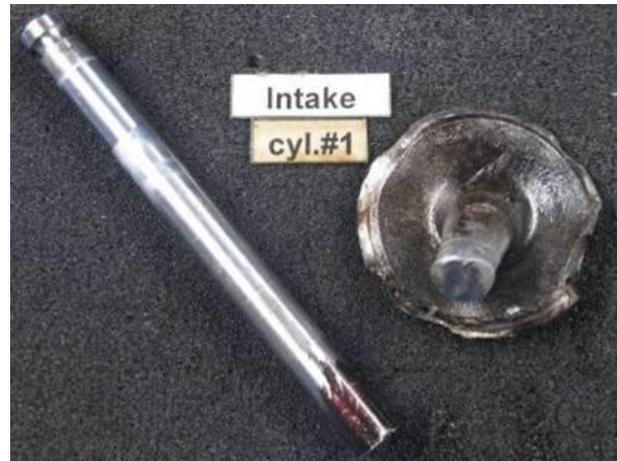
This article presents a case study for a failure analysis of a broken intake valve. This fracture took place in a gasoline engine (designed for passenger cars) during an endurance test (entitled 500 hours general cycle). During this durability test, the engine torque reduced sharply and therefore, the test was stopped after 161 hours. After more investigations, it was observed that one of intake valves in the

cylinder number 1 was broken. This event also caused other damages on the piston and the cylinder head. These failures in the intake valve are shown in Figures 1 and 2.

Figure 1: The broken intake valve in a gasoline engine during an endurance test

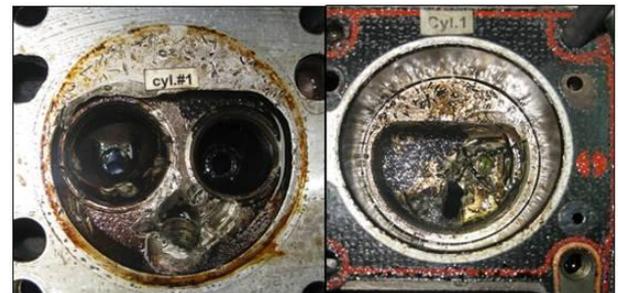
Figure 2: Damages on piston and cylinder head faces according to the failure of the intake valve

becomes a reversal cyclic loading in the valve shaft. At last, the valve can be locked in its guide due to an un-allowable deformation. This locking of the valve system causes the valve to remain opened and then causes crashing of the piston and therefore, leads to damages in the piston and the cylinder head (as shown in Figure 2).

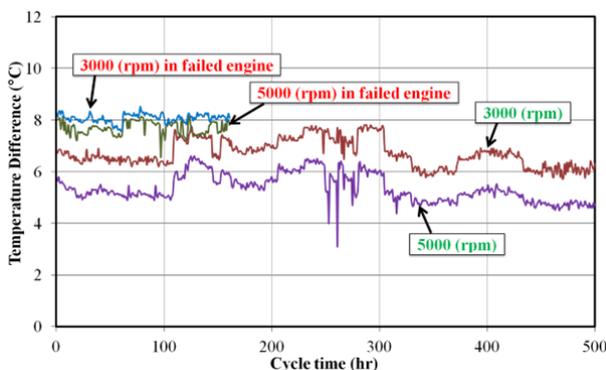
As mentioned, one important factor in these thermal deformations is the heat transfer in the engine. The temperature difference between inlet and outlet of coolant temperatures can describe thermal conditions of the engine. This value is shown in Figure 3 for two different engine speeds (3000 and 5000 rpm at full-loaded conditions) during two endurance tests on the same engine (without any failures during 500 hours of testing), comparing to this engine which the intake valve was broken at 161 hours. These results demonstrate that the temperature difference between inlet and outlet of coolant temperatures for this engine (with the failed intake valve) is higher than the other one which had no failures. This value is about 8°C for the failed engine in comparison to 6°C (as an average value) in the engine without failures.

Figure 3: The value of the temperature difference between inlet and outlet of coolant temperatures

It means that the heat transfer system of the failed engine was not working in a proper situation comparably to the other engine. This phenomenon can be due to various reasons such as pump defects. In other words, the engine has worked in a hot condition and then, one reason for breaking of the intake valve can be this hot condition of the engine. Higher temperature leads to excessive thermal expansions in the valve shaft. Then, the valve can be exposed to the misalignment and therefore can be exposed to an external bending force. As the valve rotates during engine working, then this force

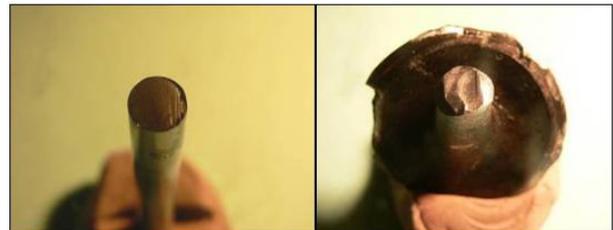
In the first step, the fracture surface of the broken intake valve was investigated as shown in Figures 4 and 5. In these figures, beach marks can be observed due to cyclic loadings and the fatigue fracture. As it is known, the valve rotates when the engine works, a reversal bending load is applied to the valve shaft. The fracture surface on the valve shaft shows macroscopic lines which illustrate the cracks growth path. On the other side of the valve shaft, the fracture surface was damaged due to the impact after the failure in the engine.

Figure 4: The fracture surface of the broken intake valve with beach marks

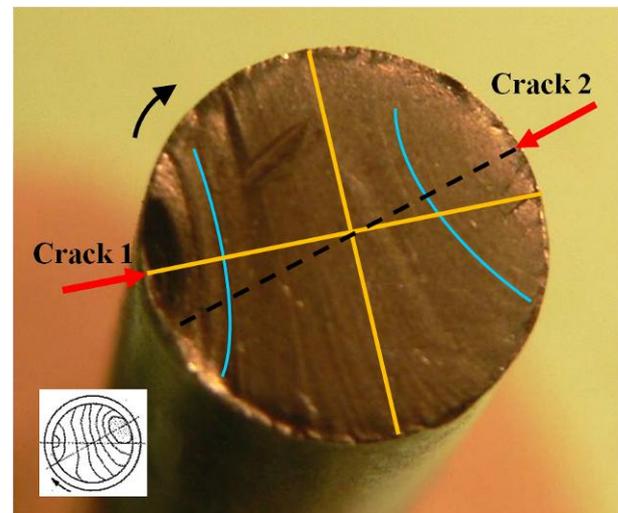
Figure 5: Beach marks and crack initiation zones on the valve shaft surface

A visual inspection of beach marks on the valve shaft surface shows two crack initiation zones (as illustrated in Figure 5, in two left and right sides). These regions are demonstrated with arrows (entitled "Crack 1" and "Crack 2") in Figure 5. As shown in Figure 5, cracks initiate at the outer surface of the valve shaft. This phenomenon occurs mostly in high cycle fatigue (HCF) regime. Then, this pattern shows a fully reversal bending as the loading

type in the valve system [9]. In other words, the mean stress is zero and the stress ratio is minus one ($R = -1$). This bending force is applied due to the misalignment, reported in Table 2. As mentioned before, this misalignment can be produced by thermal deformations due to hot working of the engine.

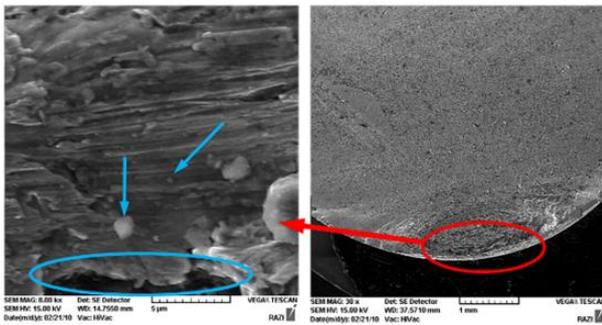
Scanning electron microscopy (SEM) images of the fracture surface are shown in Figure 6. A defect near the outer surface of the valve shaft (shown in the right side of Figure 6 which is that region entitled "Crack 1" in Figure 5) existed which could cause a crack initiation.

This zone is a three dimensional dislocation which has become active during the fatigue failure. Also, the oxide and carbide particles can be probably observed (shown by arrows in Figure 6) near the crack initiation zone.

Figure 6: SEM images of the fracture surface with different magnifications

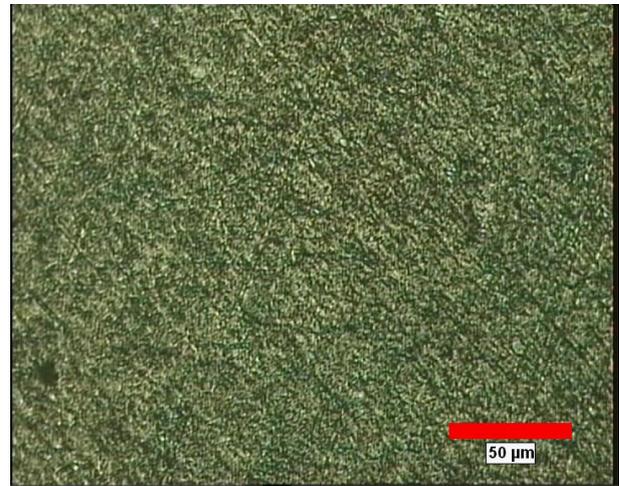
In Figure 7, it can be seen that the microstructure of the valve shaft material consisted of a tempered

martensite [1, 8]. This microstructure confirms the heat treatment process which is also revealed by the hardness. As mentioned before, the material of the intake valve shaft is made of 1.4718 steel (X45CrSi9-3) which includes chrome and silicon elements [7].

Figure 7: The microstructure of the valve shaft made of 1.4718 steel (X45CrSi9-3)

The microstructure of the material has a conformation with the specification (the standard map) of the valve system. As it can be seen in Figure 7, there exist no unusual pores or defects due to the casting process or the heat treatment process in the material of the valve shaft.
