Technical Report

Failure analysis of a dynamometer drive shaft coupled to an engine

¹Irankhodro Powertrain Company (IPCO), Tehran, Iran, m_azadi@ip-co.com

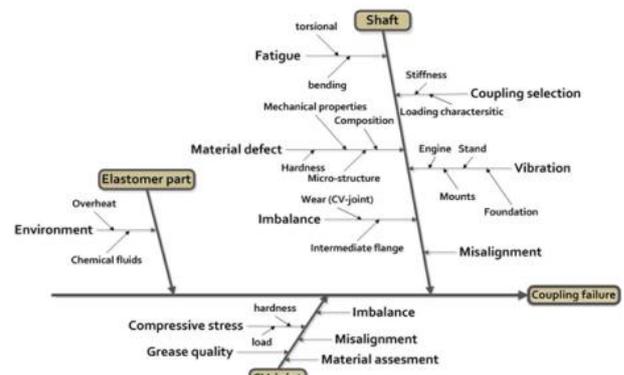
Figure 1: The fishbone for the failure of the coupling system

Root causes were analyzed in a fishbone diagram, shown in Figure 1. As illustrated, the coupling failure can happen in three parts including the shaft bar, elastomer parts and CV-joint components. For each component, there exist several reasons for the failure. For elastomer parts (rubber elements), the environment can be a cause for the failure such as the overheating effect and existing aggressive fluids. The Hertzian stress, the grease quality, the residual imbalance, the misalignment and material defects can be reasons for the failure in CV-joint components. For the shaft failure, one reason can be poor fatigue properties under torsional and bending loads. Other important reason can be the misalignment and the imbalance, when the coupling system is assembled between the dynamometer and the engine.

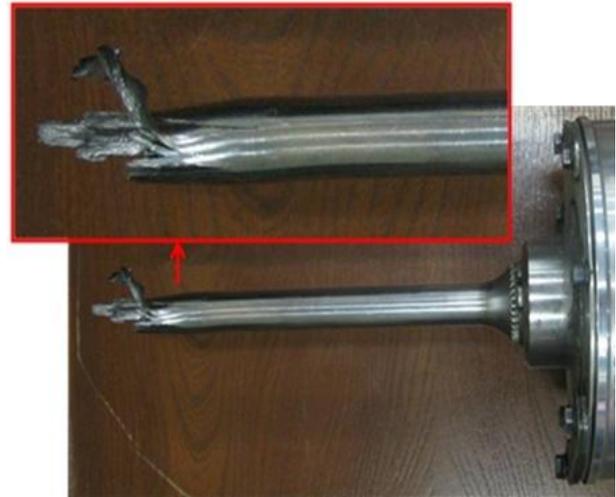
Figure 3: A failed coupling system after 1200 hrs operation

The highly flexible coupling system, which had been verified appropriately for determined test procedures and certain internal combustion engines, has failed on several occasions. A schematic picture of the engine test bed, the coupling system and its components are shown in Figure 2. The coupling system contains three major components: the titanium alloy bar shaft, engine-side joints (including the CV-Joint components and the boot) and dynamometer-side joints (which was composed of elastomer parts, the friction bearing system, the trunnion, the casing system and the hub). Figure 3 illustrates an example of these coupling systems, in which the shaft was failed after 1200 hrs operation. As it can be seen, a longitudinal crack was distantly stretched through the shaft.

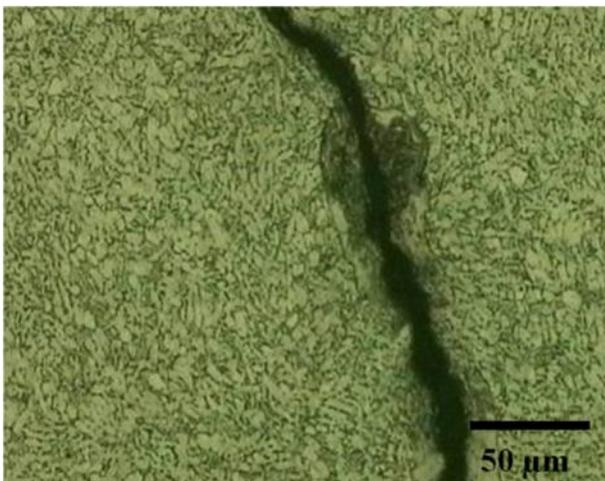
Figure 4: The microscopic image of the coupling material near a cracked zone

In Figure 4, it can be seen that the micro-structure of the coupling material consisted of α and β phases, in which the distribution of the β phase was proper in the α solid phase [2]. Therefore, the micro-structure of the material (mentioned as a branch in the fishbone diagram) could not be a reason of the failure.

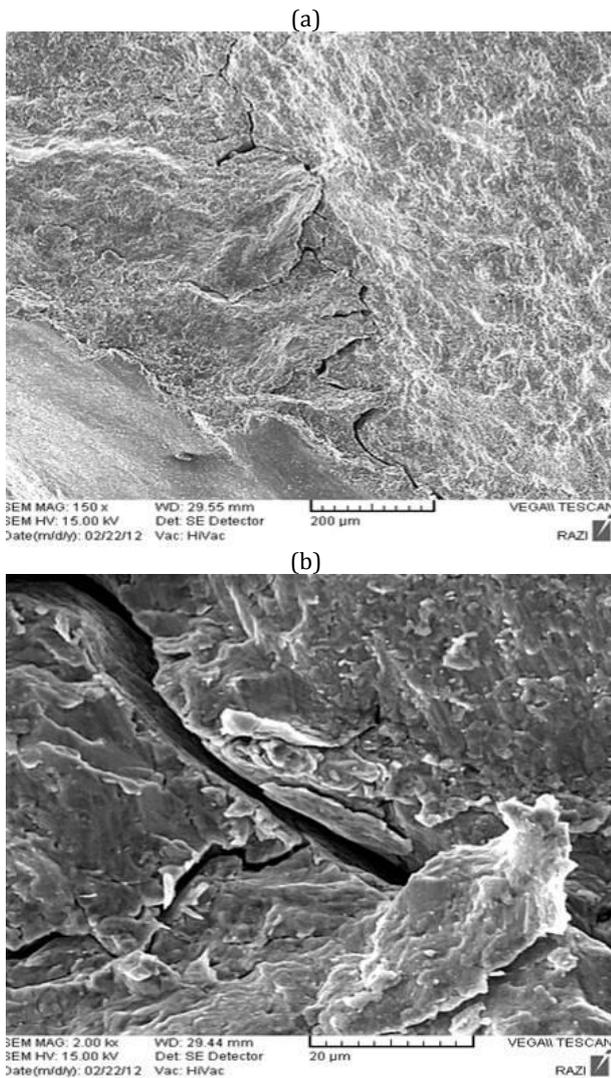
Figure 6: SEM images from cracked zones of the shaft with various magnifications

To investigate the cracked zone more accurately, the fracture surfaces were studied under a SEM. Their results are shown in Figure 6 with various magnifications to highlight micro-cracks. It could be predicted that cracks were initiated due to torsional or bending fatigue loadings. Figure 7 demonstrates the fracture surface, containing cleavage marks [7], which shows the brittle fracture.

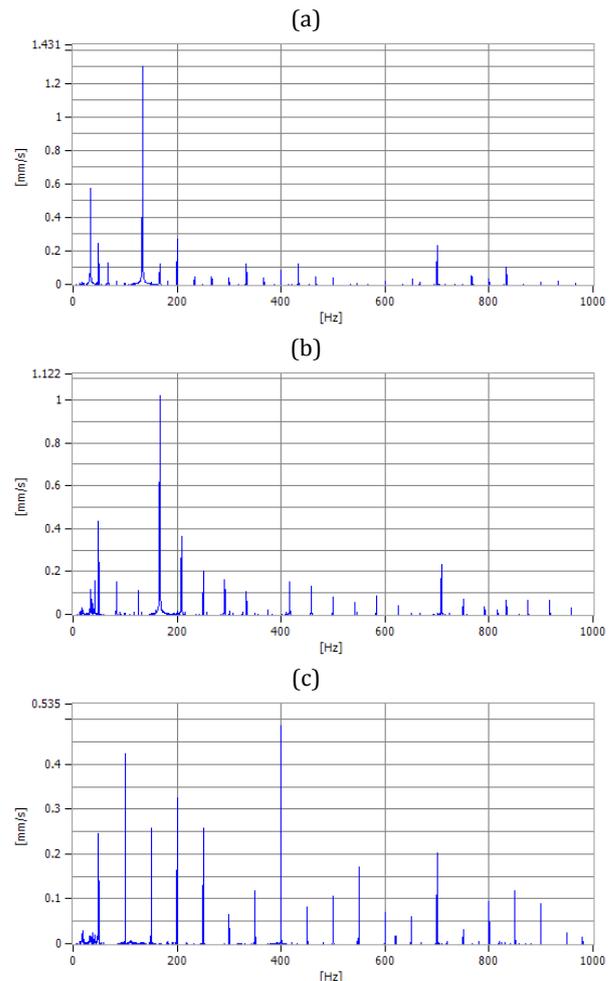
Figure 9: The vibration spectrum measured at (a) 4000 rpm, (b) 5000 rpm and (c) 6000 rpm of the engine speed

In Figure 9, three vibration spectrums in 4000, 5000 and 6000 rpm of the engine speed are shown. In all of them, no extra vibration could be reported. This test has been performed for different situations. The vibration velocity was lower than the value, mentioned before as a criterion. Moreover, vibration picks in Figure 9 are mainly due to the residual imbalance, the small misalignment and combustion knocks, which could be negligible.

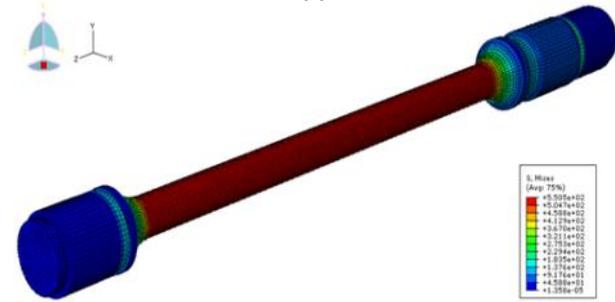
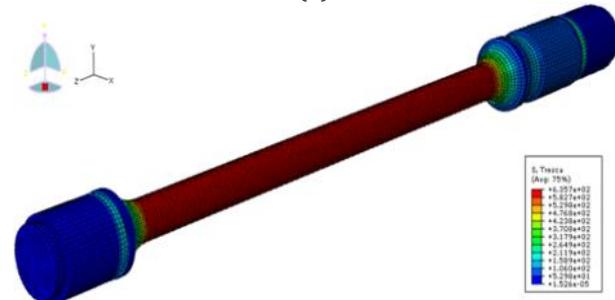
Figure 11: FE results including (a) the Von-mises stress and (b) the Tresca stress

Figure 11 demonstrates FE results including Von-mises and Tresca stresses. These results are related to 400 Nm torque. The maximum Tresca stress was calculated as 635.7 MPa in comparison to 550.5 MPa of the Von-mises stress. It means that the Tresca stress is more than the Von-mises stress, since the torsional stress is considered by the difference of maximum and minimum principal stresses in the Tresca criterion.

As an important note, to account torsional loading in the coupling system, the Tresca approach is preferable to the Von-mises approach for the mechanical analysis. Based on Von-mises criterion, considering 786 MPa yield strength of the shaft alloy [5], the safety factor could be calculated as 1.43. Having used the Tresca criterion, the safety factor becomes 1.24. Thus, the coupling shaft could withstand more than 400 Nm torque, statically.
