Failure Analysis of a Four Cylinder Diesel Engine Crankshaft Made From Nodular Cast Iron

Abstract

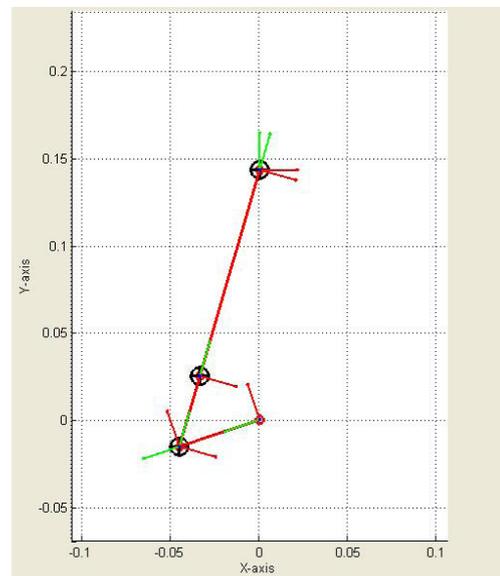
Fig 5. Mechanism used in dynamic analysis

Dynamic analysis of a crank and slider can successfully consider the combine effects of combustion pressure and inertia forces. This three member mechanism is shown in Fig.5. The maximum pressure of 46.2 bar was expe-

rienced in the cylinder during combustion. This pressure was exerted on the top of the piston in the dynamic analysis. Since the amount of pressure in suction, exhaustion and compression is very low in comparison with combustion pressure, it can be reasonably neglected in analyses of these three stages. Piston diameter and mass were 88.3 mm and 505 gr, respectively. A 181 mm, length connecting rod has been connected into both piston and crankshaft. Connecting rod's smaller and bigger hole diameters were 20.948 mm and 53 mm respectively. Its mass was considered 740 gr in the dynamic analysis. Engine revolution of 30000 degree per second has been considered as angular velocity of the crank in the dynamic model.

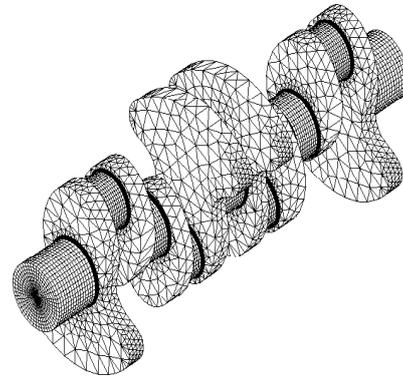
Fig 6. Finite Element Mesh.

A three dimensional finite element model was constructed to assess the stress state in the fractured crankshaft. The model is illustrated in Fig. 6. Twenty noded finite elements were used to discretize the crankshaft. Finer mesh was used in the regions of fillet where severe stress gradient is expected to be present. Linear elastic material behavior was considered by introducing Young's modulus of 178 GPa and Poisson's ratio of 0.3. There are five fixed journals in the studied crankshaft which only can only rotate around their own axes. These journals were constrained in the radial and axial directions in the finite element model. The first journal was also fixed in the axial direction to prevent the crankshaft to move axially. The calculated equivalent pressures from the dynamic analysis were recalled here and were distributed on the surface of remaining journals for the analysis of each engine cycle. Torsional torque that is exerted to crankshaft during its operation was calculated by equation 2.

Four cases, i.e. combustion in each cylinder, were examined by alteration of the boundary condition in the finite element model. Results revealed that the most dangerous case has occurred in the first crankpin when the third cylinder was combusted. The equivalent von Mises stress distribution of the whole crankshaft during combustion of third cylinder is shown in Fig. 7. The maximum equivalent stress is 62.7 MPa which is about 15% of the yield stress of the material.
