Technical Report

Failure analysis of a dynamometer drive shaft coupled to an engine

¹Irankhodro Powertrain Company (IPCO), Tehran, Iran, m_azadi@ip-co.com

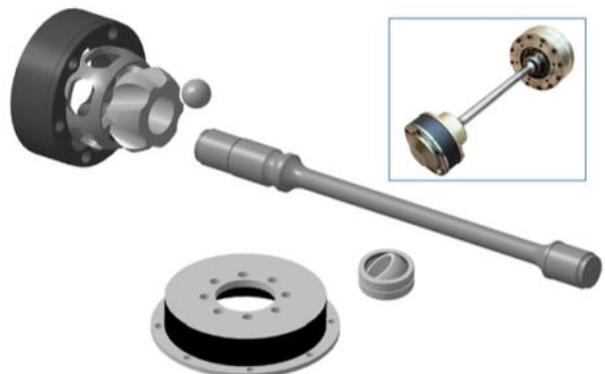
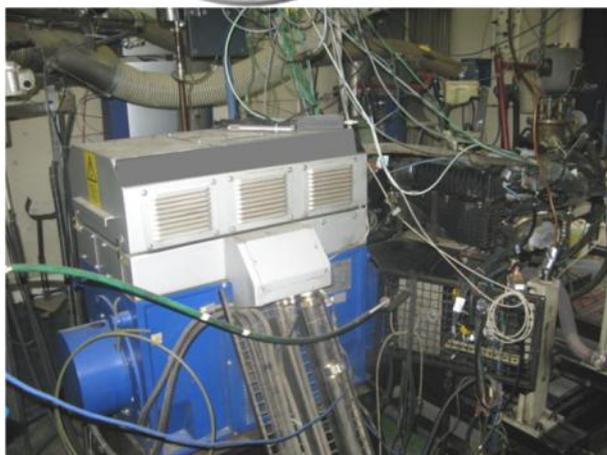
Figure 2: The view of the engine test bed and components of the coupling system

The highly flexible coupling system, which had been verified appropriately for determined test procedures and certain internal combustion engines, has failed on several occasions. A schematic picture of the engine test bed, the coupling system and its components are shown in Figure 2. The coupling system contains three major components: the titanium alloy bar shaft, engine-side joints (including the CV-Joint components and the boot) and dynamometer-side joints (which was composed of elastomer parts, the friction bearing system, the trunnion, the casing system and the hub). Figure 3 illustrates an example of these coupling systems, in which the shaft was failed after 1200 hrs operation. As it can be seen, a longitudinal crack was distantly stretched through the shaft.

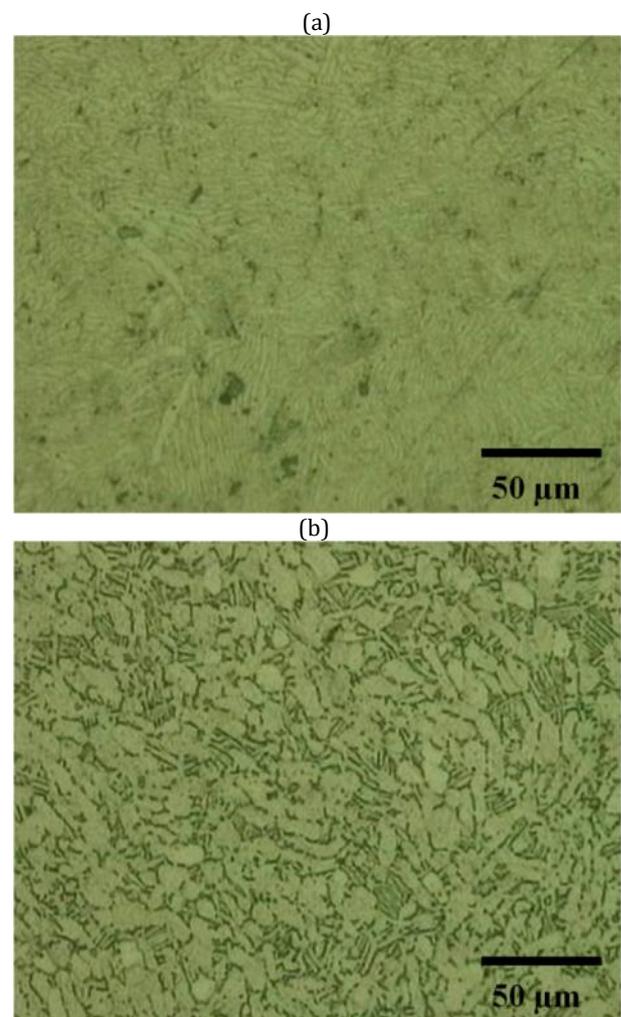
Figure 5: Microscopic images of the Ti-Al4-V6 alloy; including (a) as-received and (b) heat-treated ones

Effectively, the micro-structure resembled to the heat-treated Ti-Al6-V4 alloy. Micro-structural images of the Ti-6Al-4V alloy, with and without heat treatment are demonstrated in Figure 5, which shows the effect of the heat treatment process on the material micro-structure of the component. It should be born in the mind that the heat treatment of the alloy includes a solution at 950°C for 1 hr, water quenching and ageing at 550°C for 2 hrs [5].

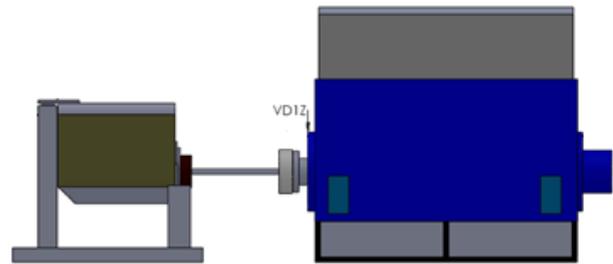
Figure 8: Vibration monitoring on the dynamometer

To make sure about the health of machines in this aspect, the vibration velocity was monitored in Z-axis in different engine conditions (shown in Figure 8).

In Figure 9, three vibration spectrums in 4000, 5000 and 6000 rpm of the engine speed are shown. In all of them, no extra vibration could be reported. This test has been performed for different situations. The vibration velocity was lower than the value, mentioned before as a criterion. Moreover, vibration picks in Figure 9 are mainly due to the residual imbalance, the small misalignment and combustion knocks, which could be negligible.

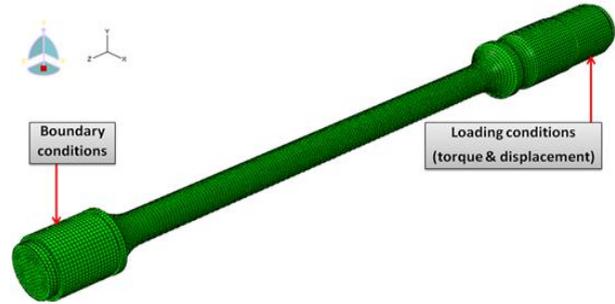
Figure 10: The meshed model of the shaft in the ABAQUS software

For further investigations, the finite element (FE) analysis of the coupling system has been performed by the ABAQUS software. A three-dimensional model of the shaft was meshed by using the C3D8R element (shown in Figure 10). In Figure 10, surfaces of boundary conditions and loadings (the torque and the displacement) are demonstrated. The meshed model includes 82211 elements, 91528 nodes and 280314 degrees of the freedom.

As an important note, to account torsional loading in the coupling system, the Tresca approach is preferable to the Von-mises approach for the mechanical analysis. Based on Von-mises criterion, considering 786 MPa yield strength of the shaft alloy [5], the safety factor could be calculated as 1.43. Having used the Tresca criterion, the safety factor becomes 1.24. Thus, the coupling shaft could withstand more than 400 Nm torque, statically.

Applying 0.2 mm displacement, as an allowable misalignment reported in the literature [8], in addition to 400 Nm torque to the FE model, shows no significant changes on stresses. These results are shown in Table 3. However, by increasing the torque to 500 Nm and the misalignment to 20 mm, stresses change. Raising the torque by 25% will intensify stresses by 25%, according to the linear behavior of the material. A 100 times bigger displacement will increase the Von-mises stress by 20% and the Tresca stress by 15%. If there is an over-range permanent displacement during the operation, the service lifetime of the shaft will reduce by 95% [7]. A radial misalignment less than 0.2 mm is allowed between the engine axis and the dynamometer flange center [7].

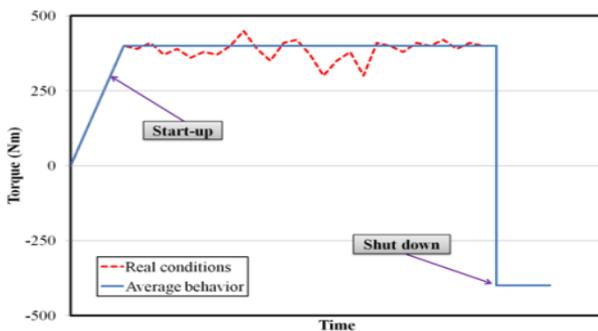
Figure 12: The schematic loading history in the coupling system

To simulate the reality of loadings, a fatigue analysis was carried out on the model. The cyclic loading type of the coupling system is in the high cycle fatigue (HCF) regime. The strategy of engine stops in the dynamometer is a reverse revolution, when the engine is working. Therefore, the loading history of the coupling can be drawn as Figure 12. When the engine works, there may be several fluctuations in the torque.

In addition, there is a negative value for the torque, since for stopping the engine (the shut-down state), the dynamometer applies a reverse torque (unlike the engine rotation direction) on the engine. If the start-up duration is not considered, between the time of engine working and the shut down time, we can say that loading conditions will be assumed to be a fully reversed loading condition with zero mean stress.

The endurance fatigue limit of the alloy was considered as 529 MPa at 10^7 cycles [5]. This limit in torsional conditions becomes 305.4 MPa, but the coefficient of the fatigue strength (the power of the stress-life relation) was not changed [9]. Therefore, the fatigue lifetime of the coupling could not be infinity based on the Tresca criterion and the coupling system had a limited lifetime.
