Study of ball bearings failure modes in an eddy current dynamometer

R. Rohani^{1*}, S. M. Jafari², M. Roozban³

ABSTRACT

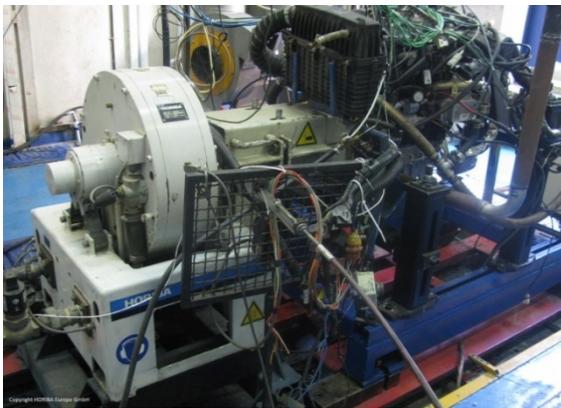
Figure1: An eddy current dynamometer coupled to an IC engine in the engine test bed (Courtesy of IPCO)

Eddy current dynamometers convert the mechanical energy of the engine to heat energy using an electromagnetic field. As a result, dynamometer's parts are subject to heat shock loads and also exposed to high temperatures. To dissipate this heat energy, dynamometer manufacturers utilize water or air cooling systems according to the capacity of the machine. In figure 1, a water-cooled eddy current dynamometer connected to an IC engine is shown.

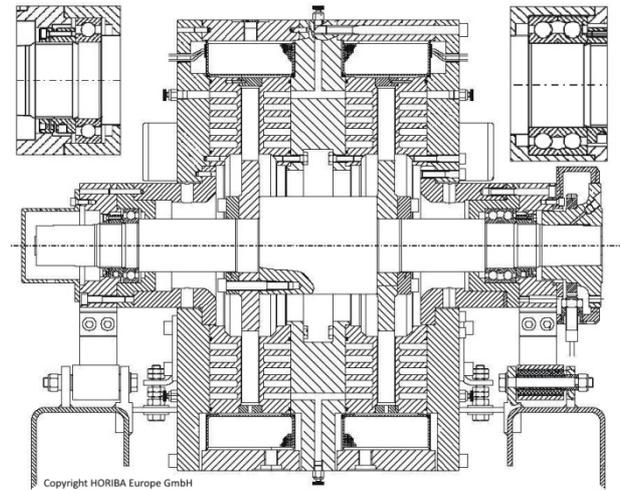
Figure2: Section view of an eddy current dynamometer (Courtesy of Horiba)

Eddy current dynamometers commonly contain angular contact ball bearings to withstand axial and radial loads but in some cases they also include deep

groove ball bearings in the rear side. The section view of an eddy current dynamometer is illustrated in figure 2.

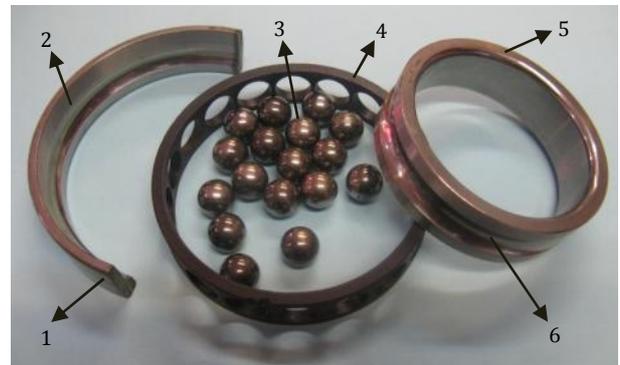
Figure 3: Components of a ball bearing; 1-outer ring, 2-outer race, 3-balls, 4-cage, 5-inner ring, 6-inner race.

To reduce the vibrations of driveline in an engine test bed, manufacturers usually use high precision angular contact ball bearings which are preloaded with a special axial force. Figure 3 shows the components of an angular contact ball bearing used in a dynamometer.

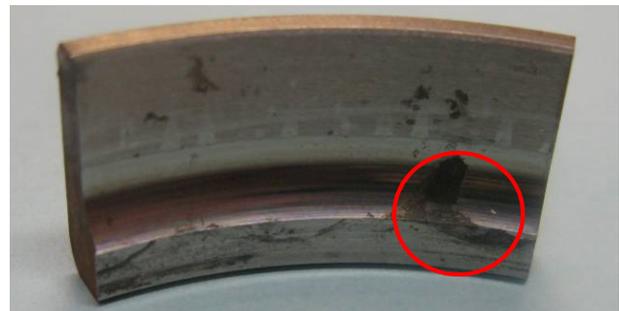
Figure 4: Fatigue damage on an angular contact ball bearing outer race

When the dynamometer shaft rotates, a continuous pulsating stress is imposed on the material of the raceways and the balls [13]. Carbides in the subsurface structure of contacting rolling surfaces are considered the weakness locations susceptible to fatigue failure initiation [12]. In fact, fatigue failure initiates with propagation of micro-cracks that finally lead to local fractures. These fractured areas in ball bearings grow parallel to the surface and cause material flaking. Flaking that is also referred to as spalling, occurs due to normal fatigue, i.e. the bearing remaining useful life has ended. However, premature flaking may have causes like external loading heavier than what had been anticipated, or radial preloading because of incorrect fits. Other failure modes e.g. indentations can also result in flaking.

A dynamometer outer race with spalling damage is shown in figure 4. The single spall indicates that the defect is not only the result of Hertzian fatigue, but also arises from the pieces flaked out of the surface. Existence of contaminant foreign objects is also probable [11].

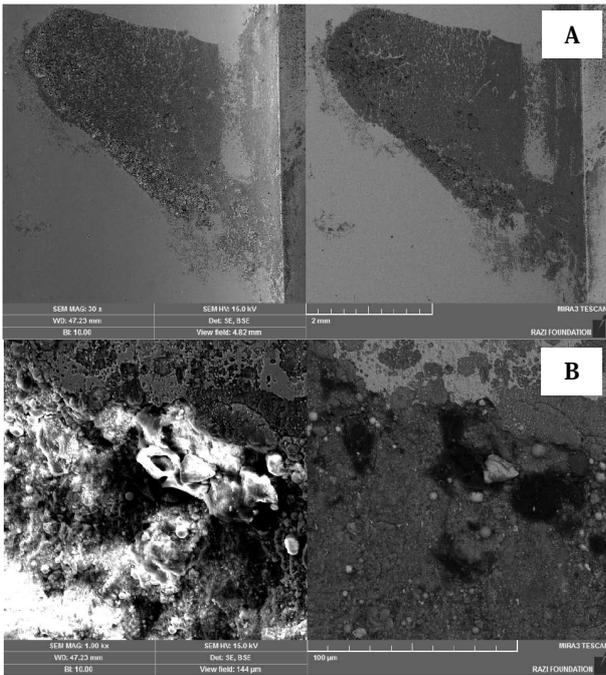
Figure 5: Magnifications of fatigue damage in Figure 4 (Mag: A-30×, B-1000×)

Fatigue damages during their progress are always accompanied by corrosion. Formation of oxidized surface on damaged area and propagation of micro-cracks are clear in figure 5 [4].

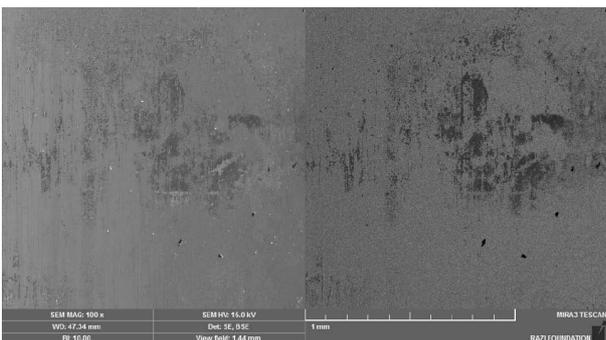
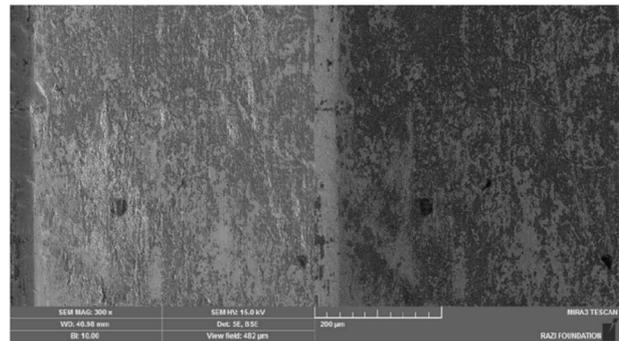
Figure 6: Magnifications of adhesive wear (100×)

High normal and tangential stresses can cause the formation of a metal-to-metal contact on a microscopic scale. This contact can raise a strong welded junction that lead to the adhesion of surfaces. When dynamometer shaft rotates, it causes rupture of adhesive junctions [13]. This phenomenon can occur in other locations near the original area as well. Insufficient lubrication can be one of the main causes of this defect. The bearing raceway and balls are subject to this damage. Adhesive wear can be the cause of other failure modes like spalling. In figures 6 and 7 this defect in a dynamometer bearing inner race is shown.

Figure 7: Magnifications of adhesive wear (300×)

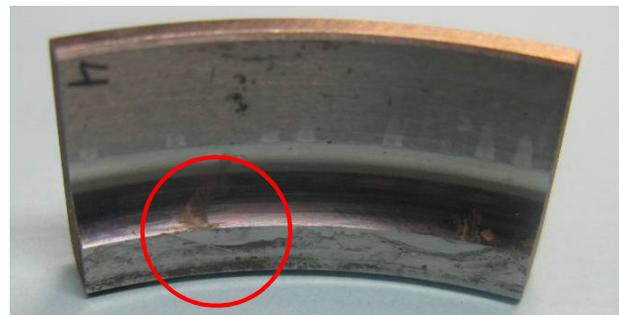
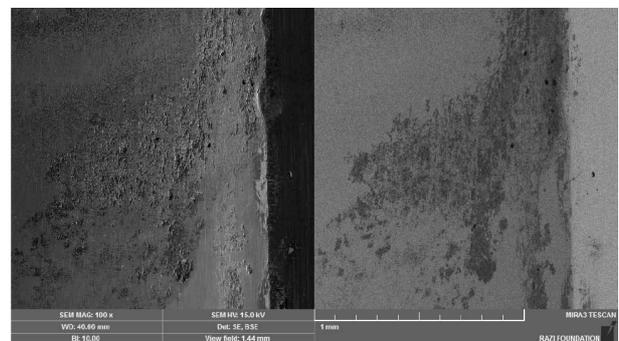
Figure 8: Abrasive wear in an angular contact ball bearing

When the plastic deformation in bearing components causes material removal and wear debris, the interaction of rolling elements and small particles lead to abrasive wear. Contamination of the bearings to foreign particles can obviously further aggravate the condition. Small hard foreign particles cause the surface roughening and accelerate abrasive wear.

Because of coarseness of abrasive particles, the surfaces with this defect are dull and can be easily distinguished. Unpacking bearings just before mounting and using fresh, clean lubricants to some extent can prevent this damage [14]. An outer race with this defect is shown in figures 8 and 9. Pitting also exists in the area.

Figure 9: Abrasive wear magnified (100×)

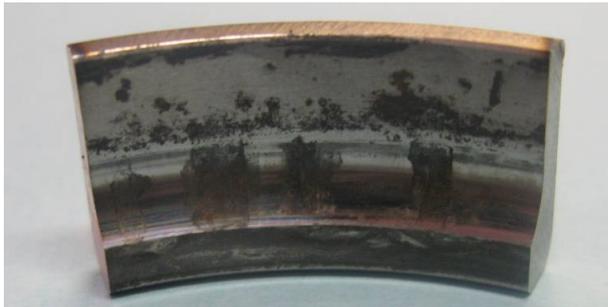
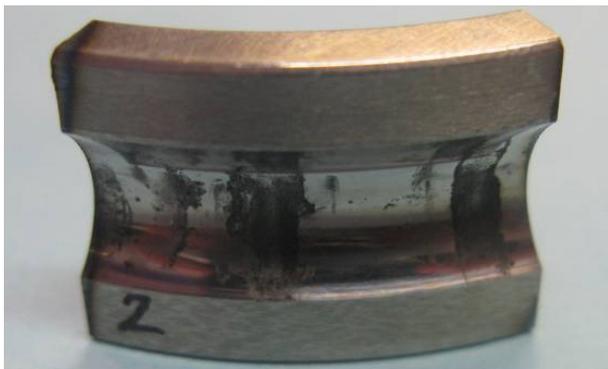
Figure 10: False brinelling in the outer race of an angular contact ball bearing

To decrease vibration and noise in dynamometers, dyno manufacturers utilize super precision bearings with fine surface finishes on the order of fraction of micron in the engine side of the shaft-rotor. Vibrations of environment influence the stationary dynamometers by producing micro-motions in the contact areas of bearing components. A dynamometer in the engine test bed never runs fulltime. The times consumed for New specimen (engine) installations, test cell software/hardware troubleshooting, and all in all when an engine test cell comes to a standstill can be the occasions in which the dynamometer bearings don't rotate but are subject to the vibrations raised

from other test cells or even the vibrations of facilities such as spot fans in the very engine test cell. The lack of lubricant film between balls and races leads to metal to metal contacts and the small relative movements as a result of vibration produce small broken particles and form depression in the raceways. The damage is called false brinelling with marks on the raceways surfaces at the ball pitch and parallel to the shaft axis. In most cases like what is shown in figures 10 and 11, oxidation of the detached particles produces red rust at the bottom of the depressions which is easily noticeable.

Figure 11: False brinelling in the inner race of an angular contact ball bearing

False brinelling can also be the result of improper transport of bearings. Bearing manufacturers recommend unloading or preloading bearings using safety devices during transport [12, 14].

For stationary dynamometers, it is good practice to modify the engine test bed foundation and use air spring systems with required settings to absorb vibrations, and also to rotate the dynamometer shaft to prevent standstill of dynamometers as much as possible. Contriving oil pump beside dynamometers and using oil instead of grease as lubricant will decrease this damage in ball bearings.

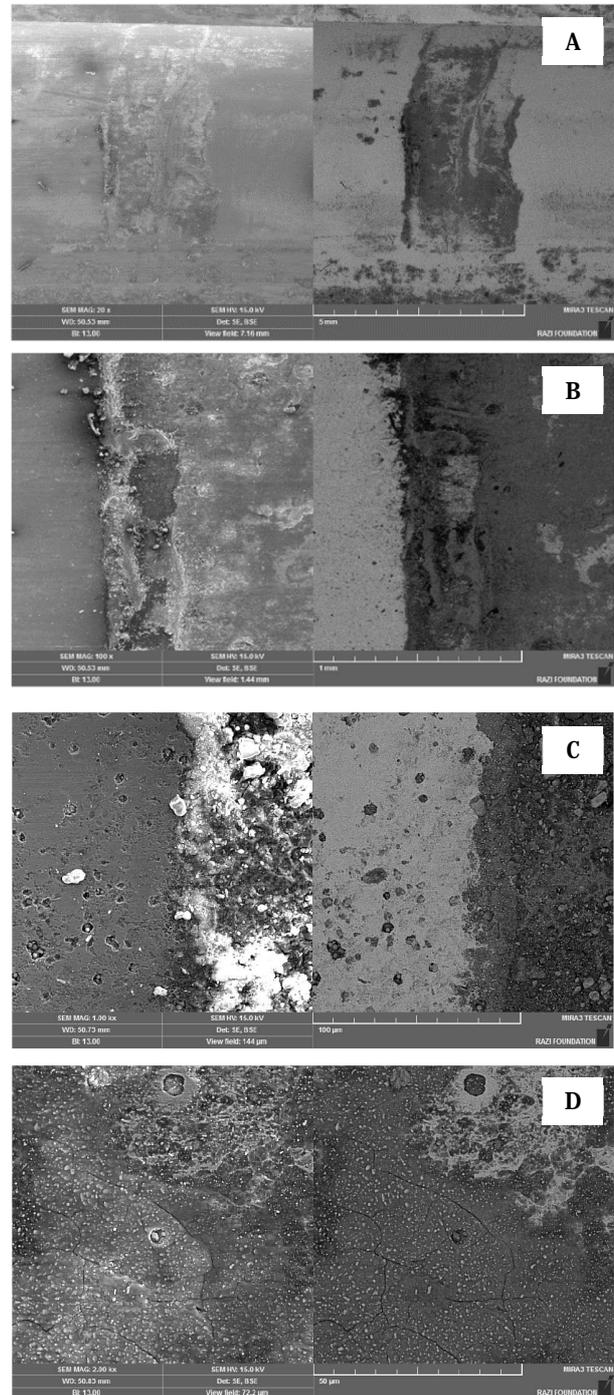
Figure 12: Magnifications of false brinelling damage in an angular contact ball bearing races (Mag: A-20×, B-100×, C-1000×, D-2000×)

The plastic deformation, material removal and oxidized surfaces of detached particles are magnified in figure 12. The bearings races surface out of brinelling marks considerably includes micro-cracks and pitting that can be derived from false brinelling. This is proved that roller bearings are more prone to this damage than ball bearings. This would be

because of the fact that balls freely rotate in every direction. All dynamometers that authors have seen yet contain ball bearings.

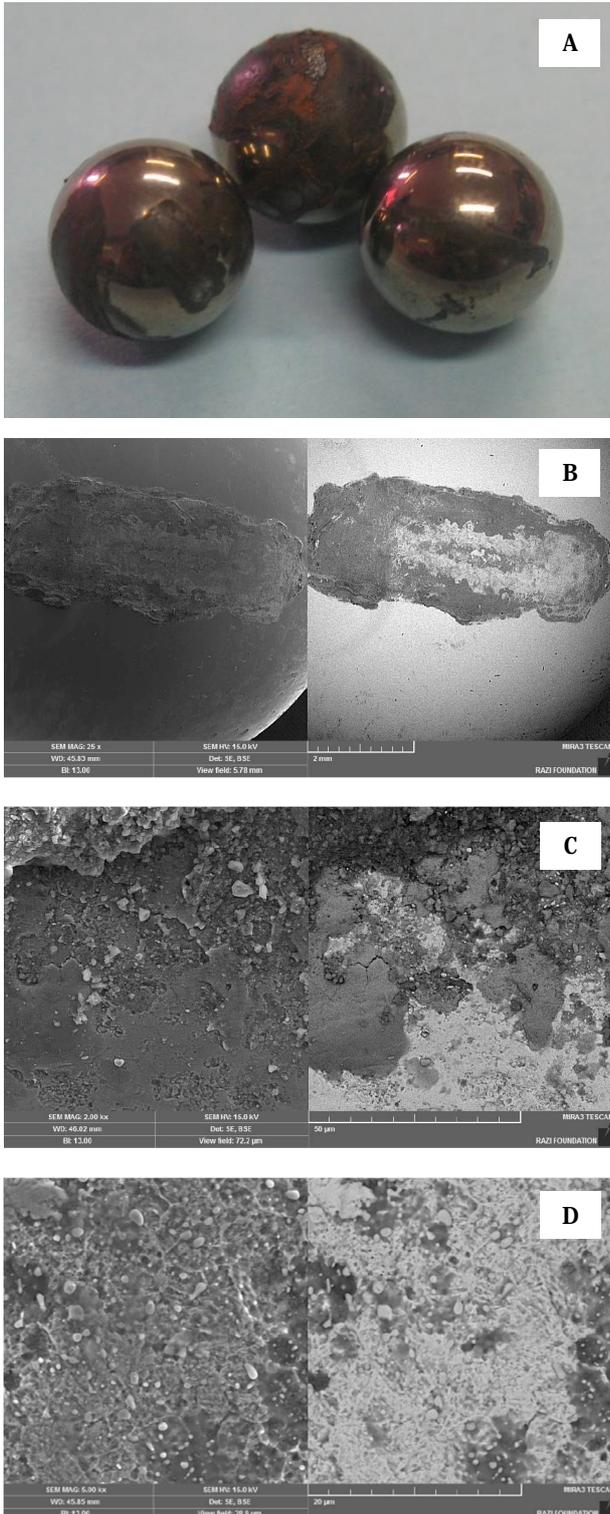
Figure 13: A-false brinelling damage in an angular contact ball bearing ball and B-magnifications (Mag: B-25x, C-2000x, D-5000x)

False brinelling marks on balls however don't follow a particular pattern distribution. They are similar to that of outer and inner races in shape but in several chaotic directions. The marks in a ball don't have similar extent. Some are wide, some narrow. It depends that how much the ball has been placed on that state. Figure 13 shows marks directions and their

microscopic surface structure. Material detachment and attachment on damaged area form a spongy structure.

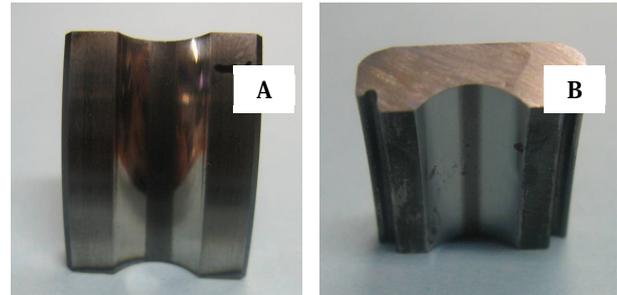
Figure 14: Smearing in a deep groove ball bearing inner race (A) and outer race (B)

In smearing, two inadequately lubricated surfaces slide relative to each other under load and

consequently the heat of high temperature generated by friction melts the surfaces in contact. Since the material is transferred from one surface to the other surface, the damaged surfaces become meaningfully rough with a torn appearance [12, 13, 14]. In dynamometer, some deep groove ball bearings have been detected to contain this damage as a dark band in the center of raceways which is the contact area of balls and races. Figure 14 shows the inner and outer races of the deep groove ball bearing damaged by smearing.

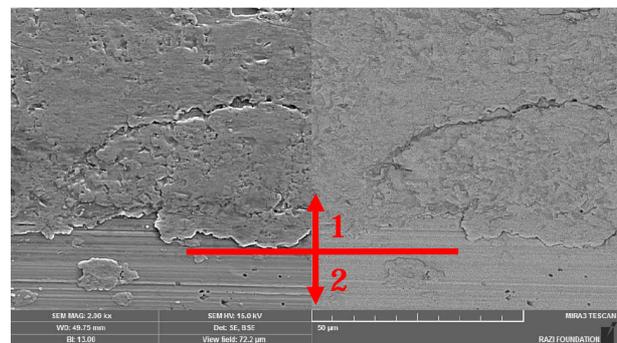
Figure 15: Smearing microstructure in the deep groove ball bearing (Mag: 2000x)

The microstructure of this damage is seen in figure 15. The area 1 is smeared surface and the area 2 shows almost no melted or torn material. Using a more suitable lubricant can significantly prevent this damage.

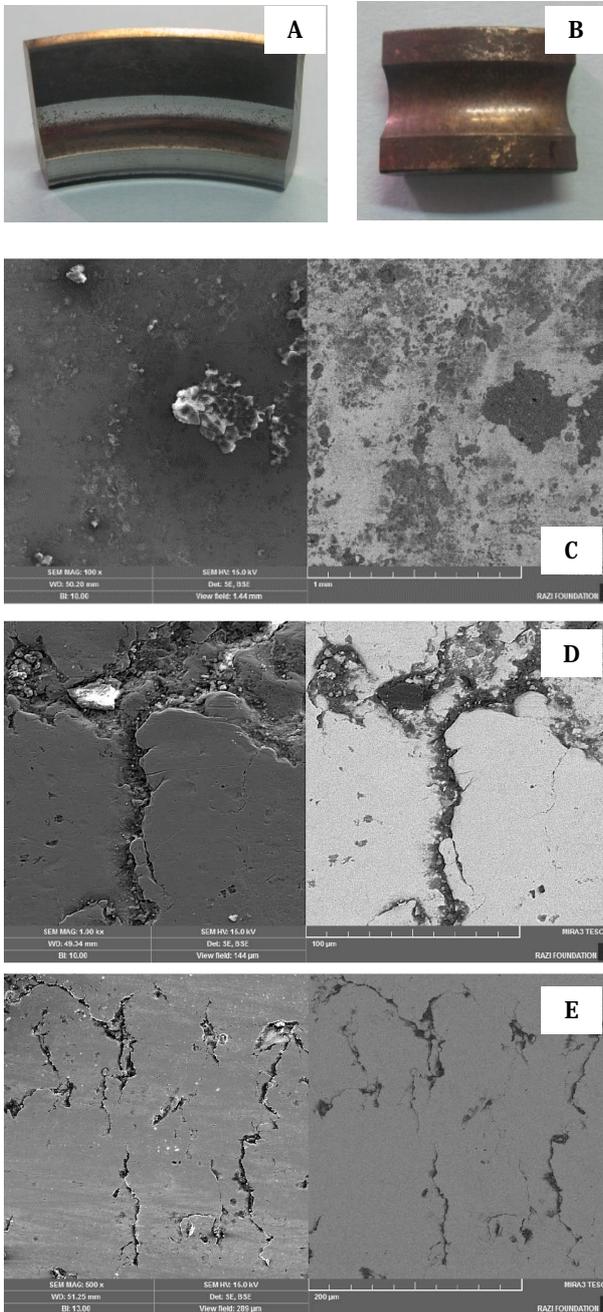
Figure 16: Deep seated rust microstructure in an angular contact ball bearing rings; A-Outer race, B-Inner race, (Mag: C-100×, D-1000×, E-500×)

The cooling water calls for special treatment to prevent dyno cooling chambers failure. Although decalcification programs in regular intervals help to prevent heat shock loads, still initiation of cracks in cooling chambers and water leakage is inevitably possible. Presence of salt in water can form galvanic

corrosion that is called water etching [14]. This would be a reason that dynamometer manufacturers never permit using salty water as coolant. Deep seated rust is very dangerous to bearings by initiating flaking and cracks similar to figure 16.

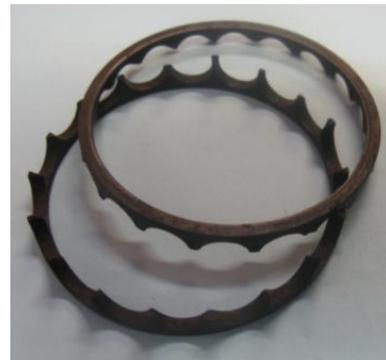
Figure 17: Failure of an angular contact ball bearing cage

Among several dynamometer failed bearings chosen to study, just one case engaged cage damage which is shown in figure 17. In the angular contact ball bearing suffered from lubricant starvation and was exposed to excessive vibration, the cage is thought to fail due to blockage owing to wedged hard particles between the cage and a ball that prevented the latter from rotation around its axis.
